TECH TIPS

FIRE INVESTIGATIONS

WHY MOTORCOACHES MAY BURN

(A MECHANICAL ANALYSIS)

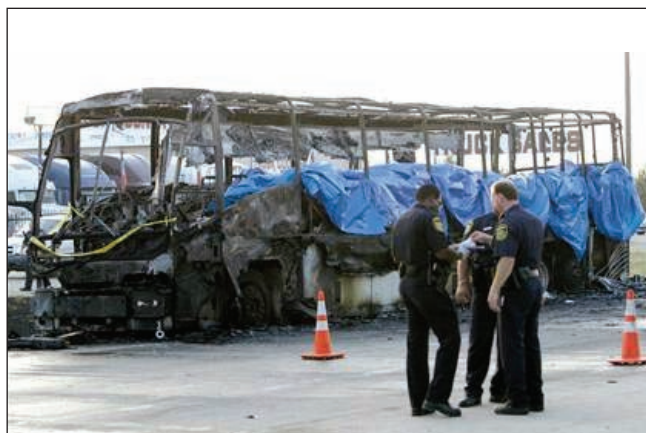
As simple as it appears, if the vehicle is in motion certain items are valid as possible causes. Likewise, if the vehicle is stationary with the engine on or off other items become potential causes. In either case, the situation is dangerous and costly in both human life and property (Photo 1).

Photo 1: Motorcoach involved in fire during Hurricane Rita evacuation (September 24th 2005)

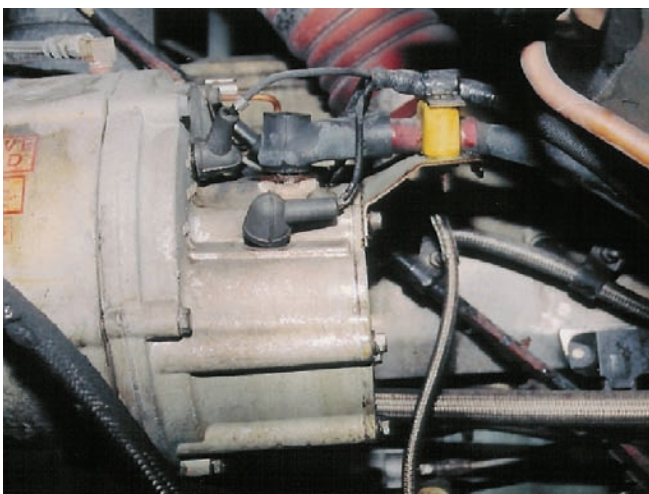
Typically with a 50-DN installation (Photos 3a & 3c), the B+ (direct battery feed) cable is routed to a large stud on the back of the alternator. This in turn is held in place with a nut (to the stud) along with various clamping methods to secure the cable end from any movement (Photo 4).

Photo 4: 50-DN, Series 60, MCI Installation

These connections must be quality checked after the alternator has been installed and inspected periodically as well as to ensure there is no movement. *It is noteworthy to point out that with some applications, these cables may need to be temporarily removed to facilitate other non-alternator related repairs. The same care and vigilance should be used whether alternator or other repairs are being made. If the B+ cable is loose, it can, by its own weight either fail the plastic insu-*

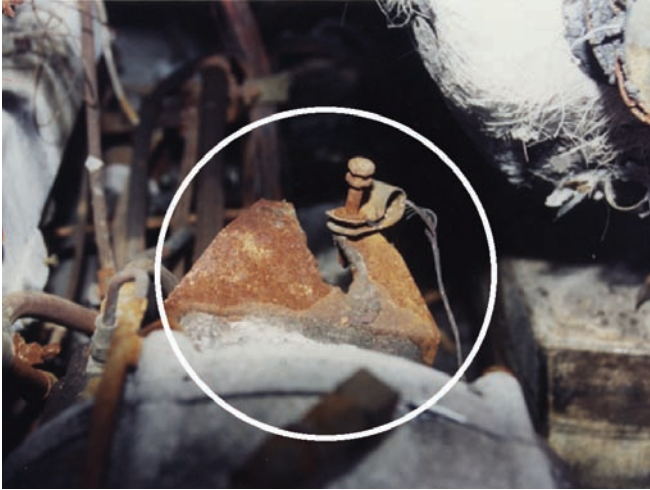
Photo 5: 50-DN, B+ Bracket, Series 60

lator material surrounding the stud at its base, internal to the alternator, or wear through the cable insulation locally and make unwanted contact with the support bracket. When this occurs the cable can act similarly to an arc welding machine and cut its way through the bracket (Photo 5).

Once the B+ cable end is free, the cable can drop, making contact with a ground source, resulting in a sustained duration spark. This is exceptionally critical in that with some engine applications the alternator is installed above and on the fuel side of the engine.

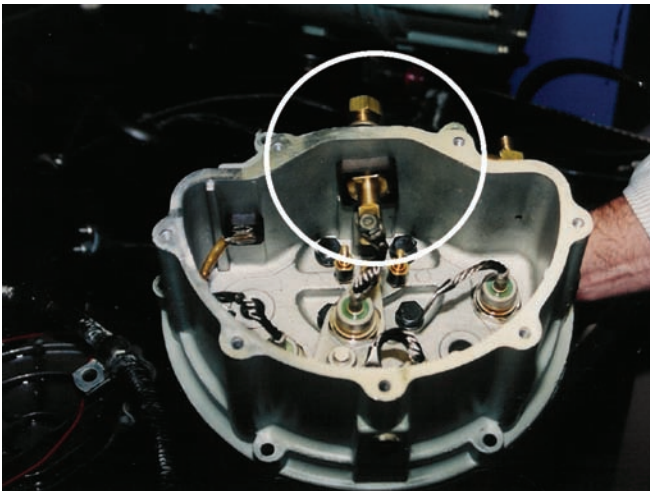
Photo 6A: 50-DN, B+ Stud Insulator

In addition to the cable and its' mounting system there is another potential fire hazard. When installing the B+ cable to the stud (50-DN) the proper torque must be used to ensure that the plastic material (internal insulator) is not broken or compromised in any way (Photo 6a). If this nut is over-torqued, or otherwise installed incorrectly, it could lead to a loose stud subsequently leading to an ignition source and fire (Photo 6b).

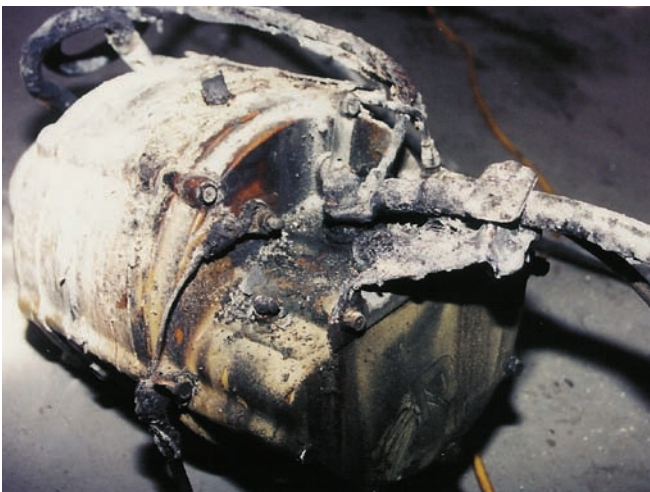
Photo 6B: 50-DN, Result of Failed B+ Stud Insulator

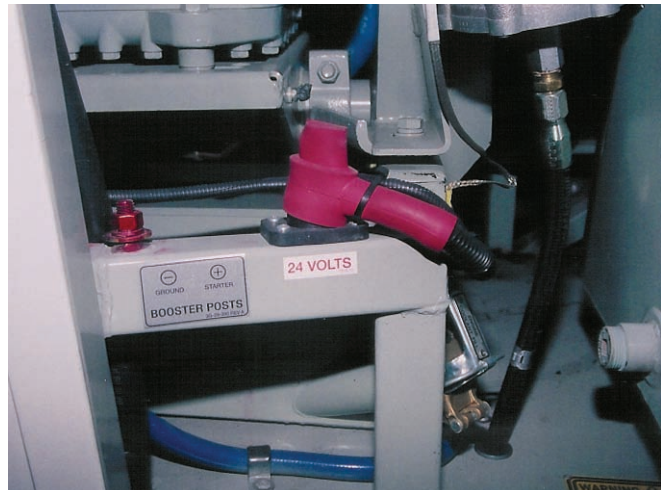
Remote Jump Post: With some applications a convenience feature is provided in the engine compartment for "jumping" a disabled vehicle. This is typically a positive (+) cable running from the starter to an exposed stud. These connections must be inspected and maintained to provide integrity. Additionally, this stud is covered with a flexible rubber boot (Photo 7).

Photo7: Remote Jump Post

This boot must be in good condition and over the positive (+) stud at all times. A loose jumping stud/cable can create a sustained duration spark similar to the alternator B+ cable.

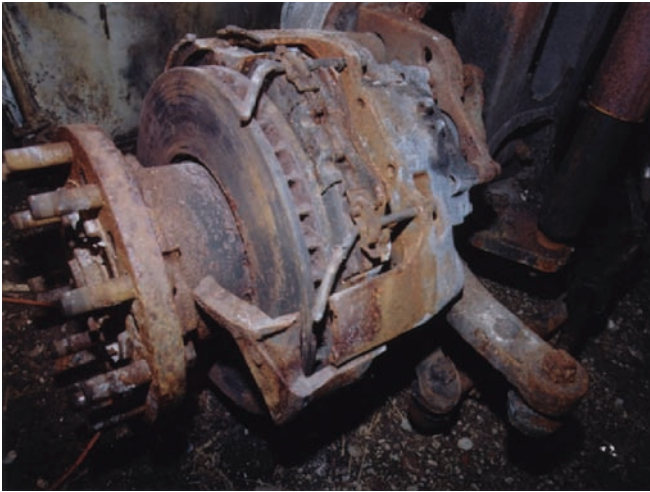
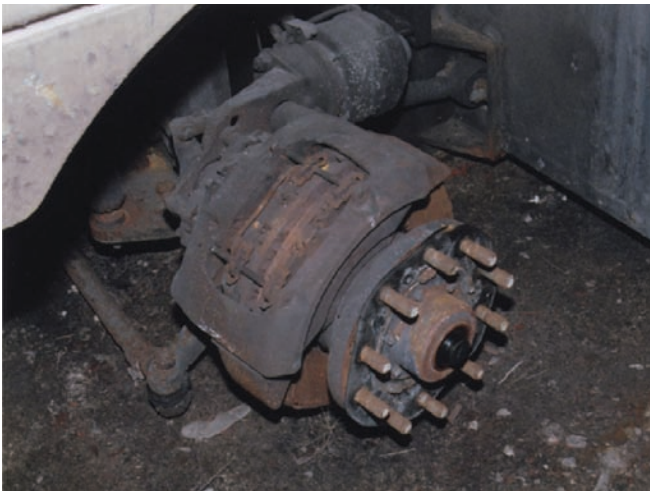
Photo 9: Disc Brake (RH Tag Axle) [Involved]

Photo 10: Disc Brake (LH Tag Axle) [Not Involved]

An additional risk exists, with disc brake applications, during a wheel bearing/hub failure. That is, as the outer bearing begins to fail, the hub load is transferred from the outer bearing to the brake caliper, brake pads and rotor. Once the outer bearing has failed completely, no longer able to support the hub load, the caliper, brake pads and rotor are then supporting that particular wheel end (Photos 9 & 10).

Once the brake caliper begins carrying the load, at that particular wheel end, the surface temperature of the brake pads and rotor (or drum) rise well above the auto-ignition temperature of the surrounding combustibles (due to friction) and eventually igniting them. The combustible material typically ignited by this failure mode is the tire(s). Tires generally revert (melt) at approximately 250°F and catch fire over the 600°F mark. It is common, although not mandatory, for the tire fire to occur when the vehicle comes to a stop. This is the condition with the least amount of air flow circulating around the brake rotors, brake drums and tires. Without air flow around these items, their temperature rises rapidly and is transmitted to the tire—subsequently igniting it. This concept of brake caliper/pad/rotor supporting the hub load can typically be seen by a thinner more worn outside brake pad as compared to the inner pad. This is due to the hub moving outward, away from the spindle. As a result of this temporary load support from the caliper, the

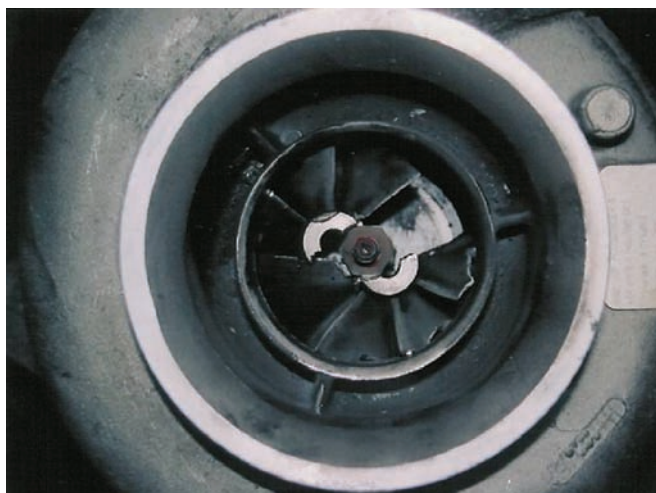
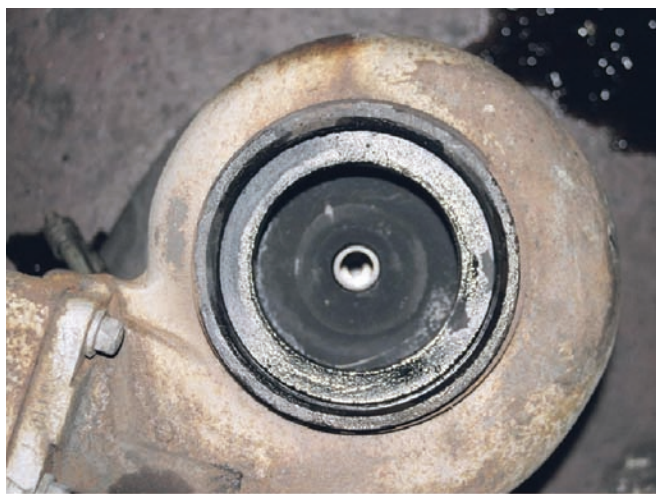
Upon a failure of this bearing system or an imbalance of either the turbine or compressor wheels contact is made within the turbocharger housing causing a rapid deterioration of the compressor and turbine (Photos 12 & 13).

Once the shaft has been re-oriented as a result of any one of the aforementioned failure modes, the shaft seal(s), which controls the lubrication oil within the bearing cavity, subsequently fails allowing oil to enter directly into the hot side (turbine) of the housing and then directly into the exhaust system (Fig. 8). This can create an auto-ignition fire within the turbocharger itself or exhaust system.

Photo 12: Failed Compressor, Series 60

Photo 13: Failed Turbine, Series 92

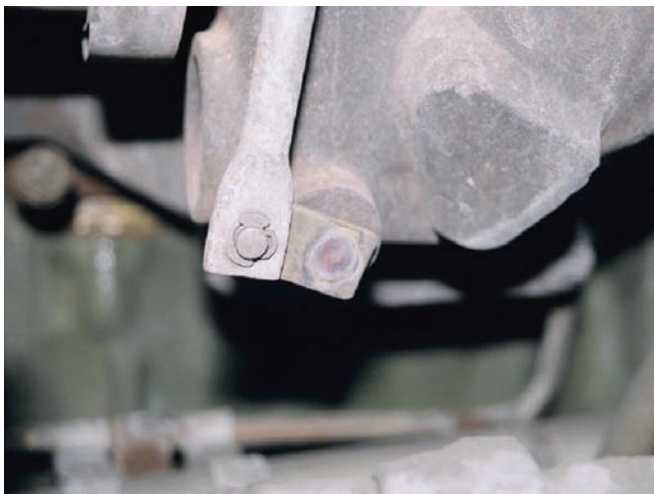
used to detect the onset of an internal turbocharger failure. If the turbocharger has experienced an internal failure the performance of the engine is compromised. Specifically, blue smoke, due to oil consumption along with reduced engine torque will be noticed. Also a specific oil leak, from the waste gate pivot point, can be observed (Photo 14). Once oil has begun to leak from this point on the tur-

Photo 14: Waste Gate Pivot, Series 60

bocharger it should be removed from service and the exhaust system should be thoroughly cleaned. To assist in preventing this failure mode; the turbocharger waste gate or variable geometry function (V.G.T.) must be confirmed. Additionally, the shaft free play, both axially and radially, must be inspected by a mechanic.

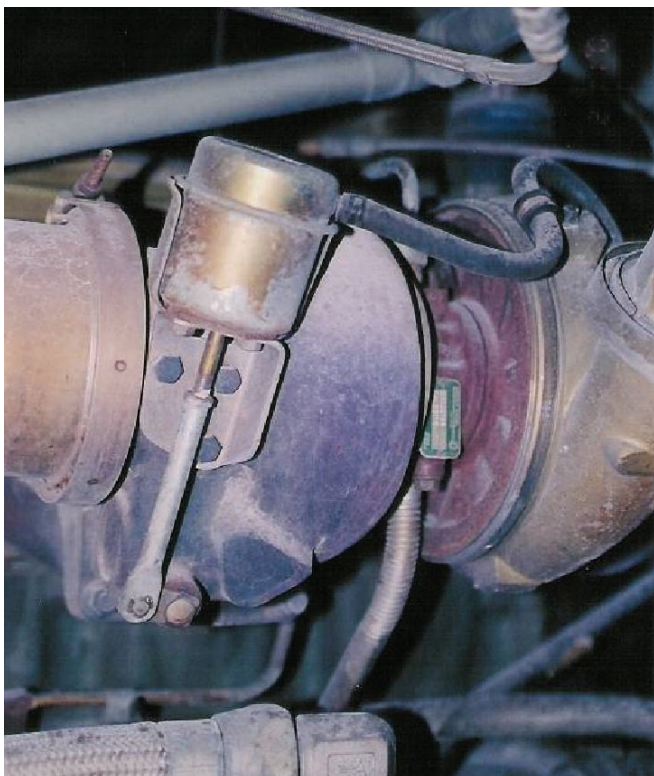
Photo 15: Waste Gate, Series 60

To confirm the function of the waste gate (Photo 15), apply regulated air pressure to the boost line (20-30 psi) to exercise the waste gate slave cylinder. To confirm the V.G.T. function (Photo 16), turn on the vehicles' ignition to "on" and observe the slave cylinder motion.

If there is no motion for either system upon these diagnostic tests, they are defective and must be replaced/repared. These two systems regulate turbocharger boost pressure. If they were to fail to regulate this pressure, it may lead to an internal failure thus leading to a fire.

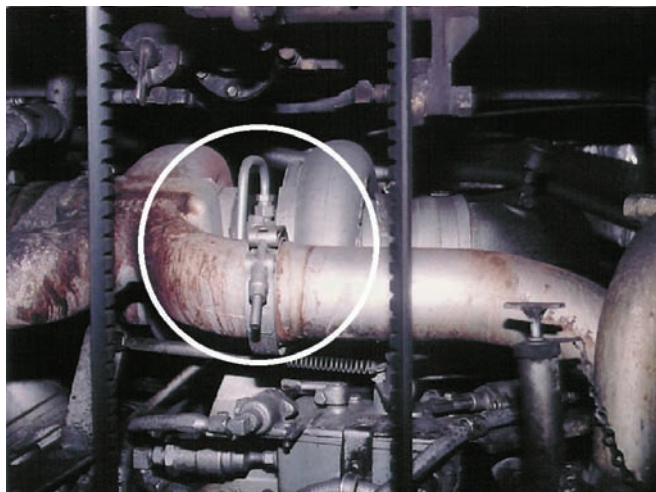
External Turbocharger Oil Lines: With the Detroit Diesel Series 92 application, there is only one external oil line. The oil supply line is positioned on top of the turbocharger and must be inspected periodically for leaks (Photo 17).

Photo 17: Turbocharger Oil Inlet Line, Series 92

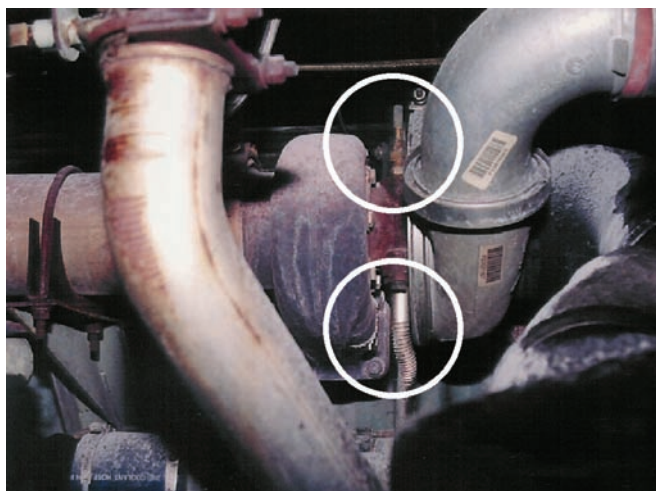
Photo 18: Turbocharger Oil Inlet and Outlet Line, Series 60

inspected (Photo 18). These turbochargers have an external supply and return oil line. In either case, a leaking oil line must be repaired to prevent an auto-ignition fire.
