TECH TIPS

FIRE INVESTIGATIONS

WHY MOTORCOACHES MAY BURN

(A MECHANICAL ANALYSIS)

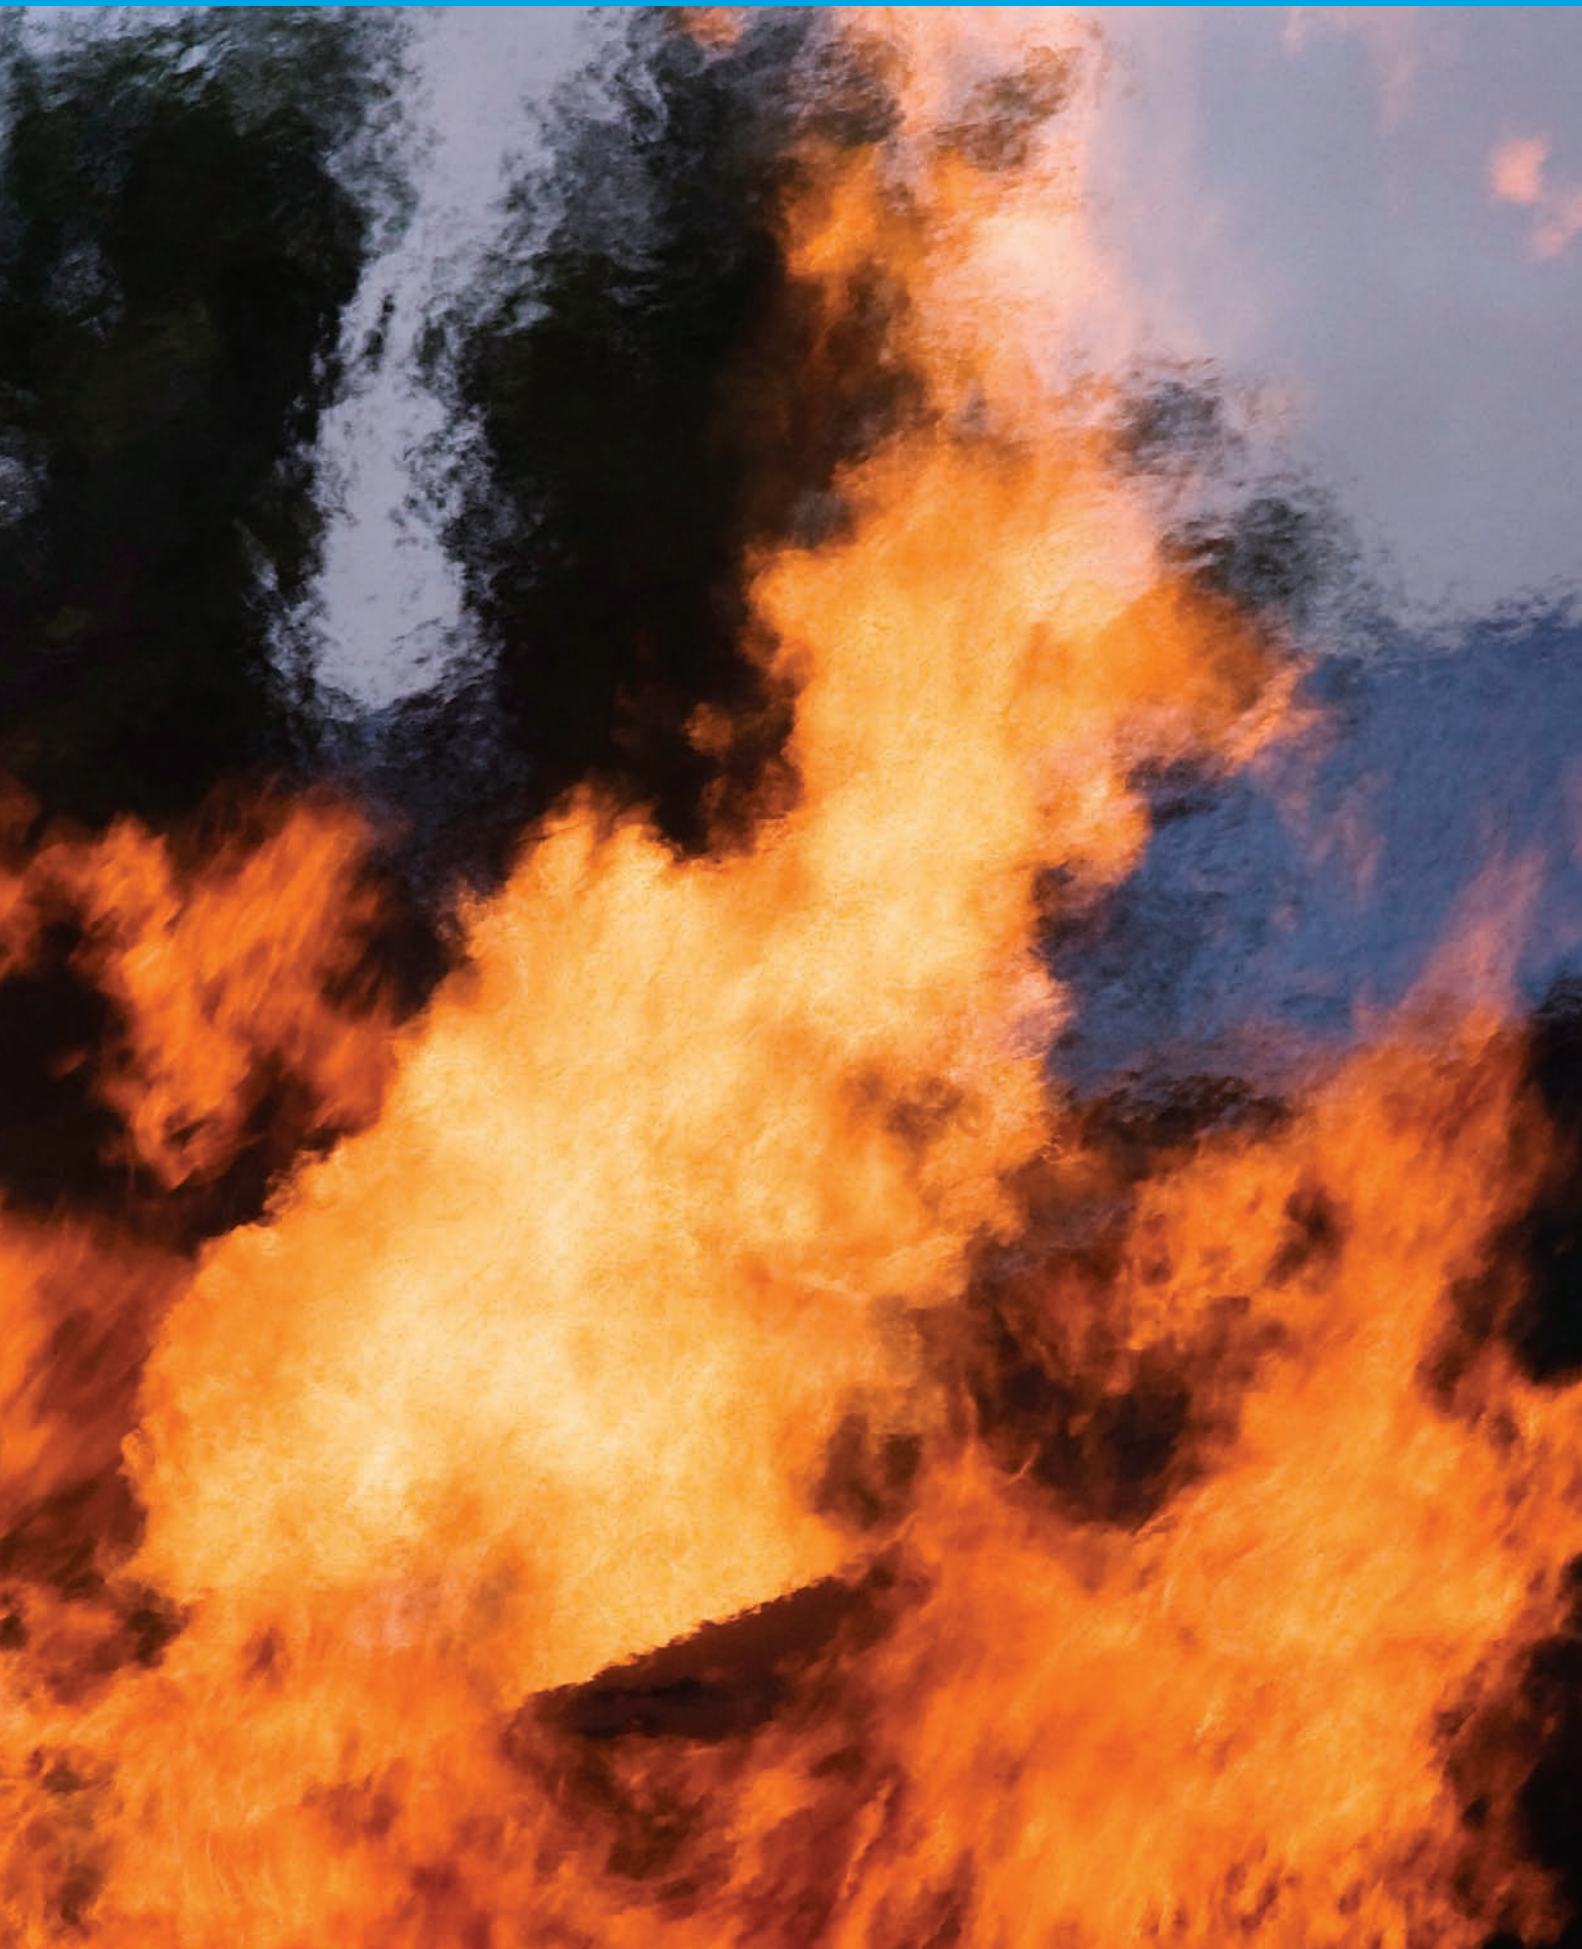
Photo 1: Motorcoach involved in fire during Hurricane Rita evacuation (September 24th 2005)

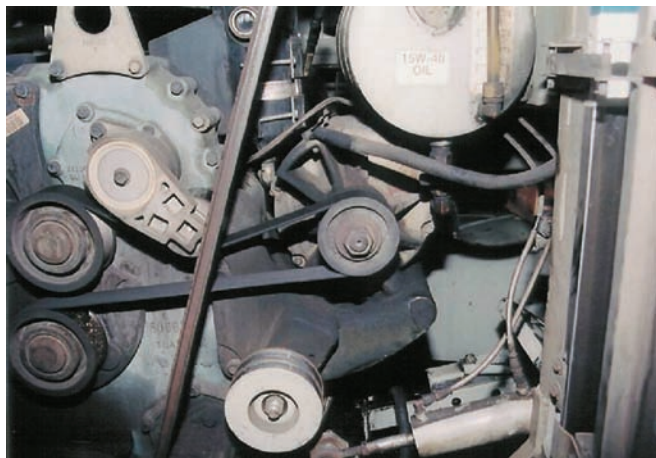
Photo 3A: 50-DN, Series 60

Typically with a 50-DN installation (Photos 3a & 3c), the B+ (direct battery feed) cable is routed to a large stud on the back of the alternator. This in turn is held in place with a nut (to the stud) along with various clamping methods to secure the cable end from any movement (Photo 4).

These connections must be quality checked after the alternator has been installed and inspected periodically as well as to ensure there is no movement. *It is noteworthy to point out that with some applications, these cables may need to be temporarily removed to facilitate other non-alternator related repairs. The same care and vigilance should be used whether alternator or other repairs are being made. If the B+ cable is loose, it can, by its own weight either fail the plastic insu-*

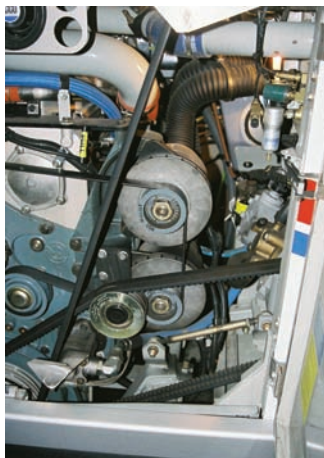
Photo 3B: Bosch T1, Series 60

nator similar to an automotive application; but larger. The typical varieties are a Delco 50-DN (Photo 3a) or an air cooled dual Bosch T1 (Photo 3b) configuration. The author must stress that these manufacturers are not being singled out for any particular reason; however, they are the most commonly found units within this type of vehicle. For most applications, the charging system for the motorcoach produces 275 amperes or more — as much amperage as a typical single family home may have. With this, the alternator (and system) carries great potential as an ignition source.

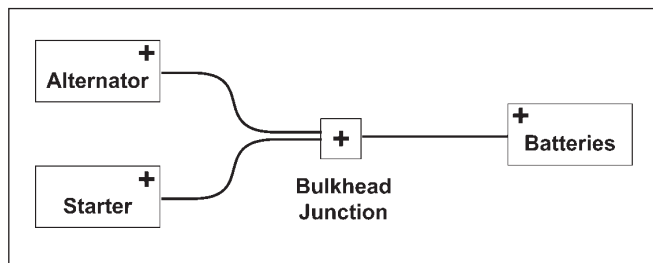
Figure 3

motor. However, this is initially routed to a bulkhead junction (Fig. 3; Photos 8a & 8b); again this is a heavy cable and must be properly connected and supported in its mounting.

Care must be given to the cable condition, cable to starter connections, as well as its' routing so that this B+ cable is not making unwanted contact and potentially coming in contact with ground as a result of an insulation breach.

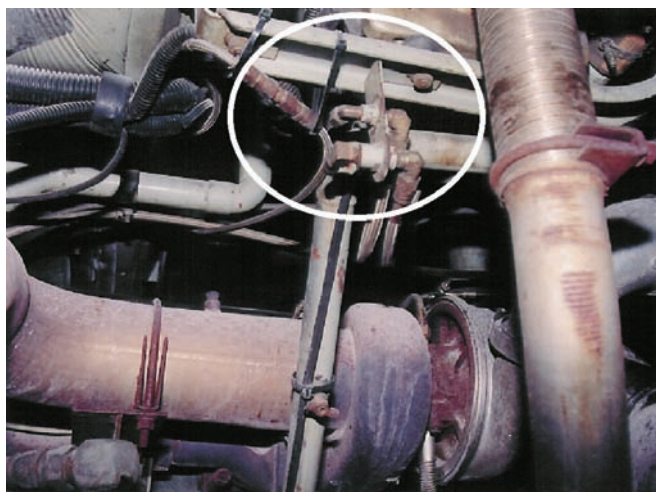
Photo 19: Looped Fuel Lines, Auxiliary Heater

Auxiliary Heaters: Also known as diesel furnaces, auxiliary heaters heat the onboard coolant when the engine is not running. However since it is a furnace which burns diesel as fuel it must be periodically inspected for function, control and integrity. Specifically, its cycle time and control must be verified to assure it is functioning when it should be, as well as, turning off when commanded. Additionally, the fuel lines must be inspected to confirm there are no leaks. In fact, in the summer months it is good practice to disconnect the heater function power supply and loop the supply and return fuel lines together (Photo 19). This will assure that fuel does not leak from the furnace itself when not in service. It should be pointed out that the heaters' exhaust pipe (Photo 20), within minutes of heater activation, reaches 375°F and continues to climb approaching the auto-ignition temperature of most of the vehicles fluids. Therefore, it is vital that
